**CanWhite Sands – Silica Sand Extraction Project
Environment Act Proposal –
File No. 6119.00
Public Comments Received From**

Comments on the CanWhite Sand Vivian Extraction Project
By
D.M. LeNeveu B.Sc (hons. physics), M.Sc. (biophysics). B.Ed.
On Behalf of What the Frack Manitoba
Oct. 5, 2021

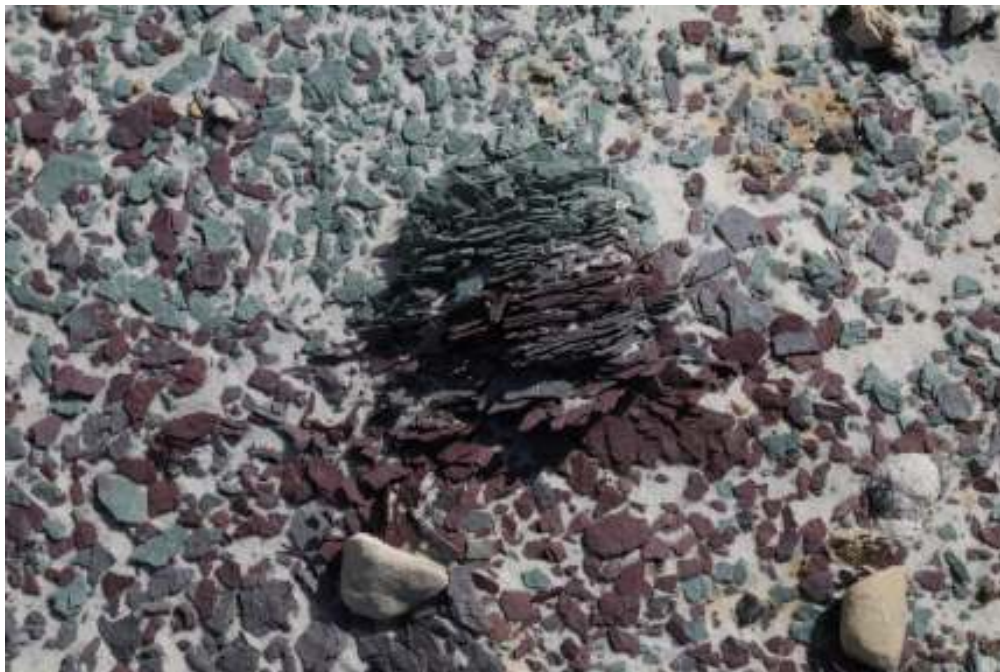
Figure 1. Photo of shale fragments extracted with the sand near Vivian Manitoba, spring 2020. The photo was taken by a local concerned citizen (name withheld for privacy reasons)

The well log from Bru 95-7 reports shale layers interbedded with sandstone below the pure sand layer at depth below surface between 72.24 to 74.68 meters. This shale could be extracted with the sand. Figure 1, a picture taken in the spring of 2020 of extracted sand piles south of Vivian, shows shale fragments interspersed in the sand. These pictures provide incontrovertible evidence that shale fragments containing pyrite and heavy metals would be extracted with the sand. The net neutralization potential, NNP, in shale for Bru 95-8, Bru 121-1, and Bru 146 shale of, 5.0, 3.0 and 3.0 respectively indicates that the shale is potentially acid generating (PAG). The NNP values likely would have been smaller indicating strong acid leaching potential consistent with literature references had the samples not been exposed to air.^{8,9}

Shale extracted with the sand would oxidize sulphide in the extraction processing tanks to form acid and mobilize heavy metals. Selenium in the shale would oxidize to a soluble form and be released as well. Most of the contaminated water from the processing tanks would be re-injected into the sandstone aquifer. Some of the contaminated water would be directed into the slurry lines. Oxidation of the selenium and pyrite in the

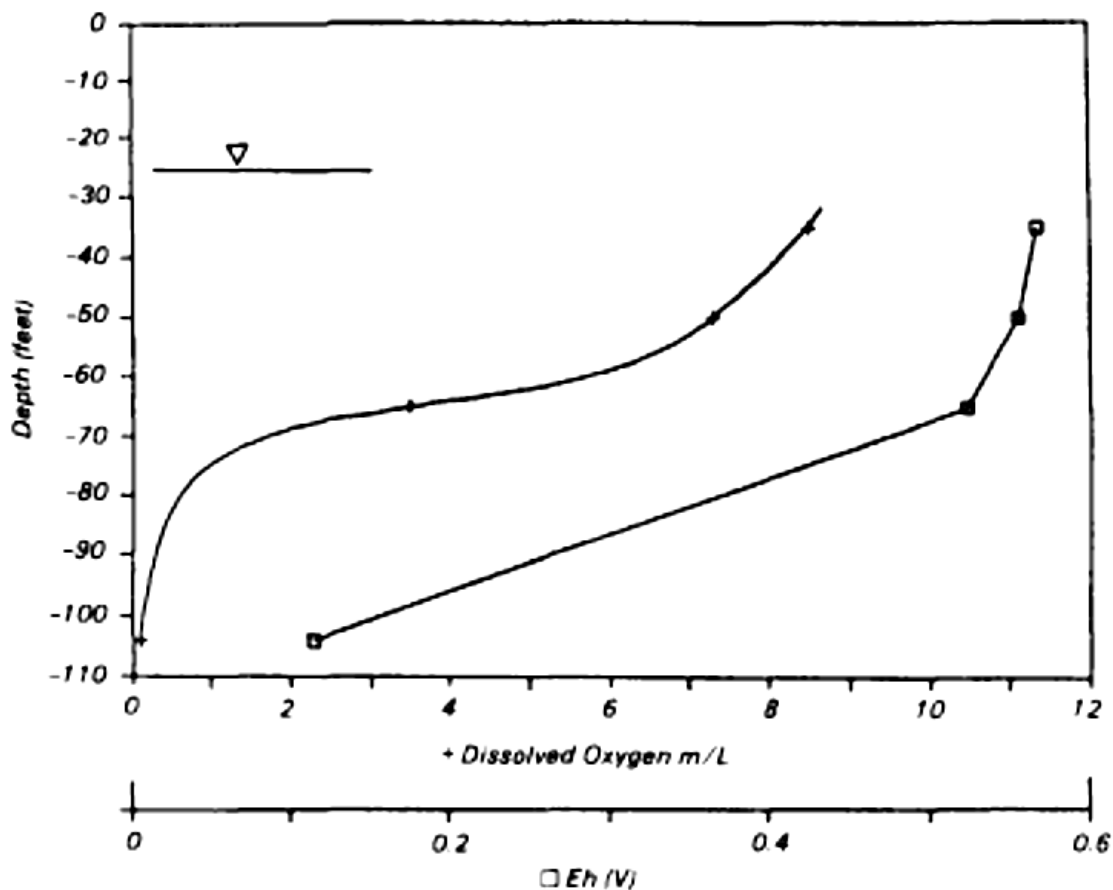
Figure 2. Concentration of dissolved oxygen and Eh (ORP) values in groundwaters of Havana lowlands aquifer, 1985. (EPA, 1986)¹⁴

Dissolved oxygen generally decreases with decreasing oxidation reduction potential (ORP or Eh). For example US Environmental Protection Agency (EPA) report EPA/600/s2-86/042 of June 1986 for an aquifer in Cuba documented that dissolved oxygen concentration is zero below an ORP of 100 mV as shown in Figure 2.¹⁴

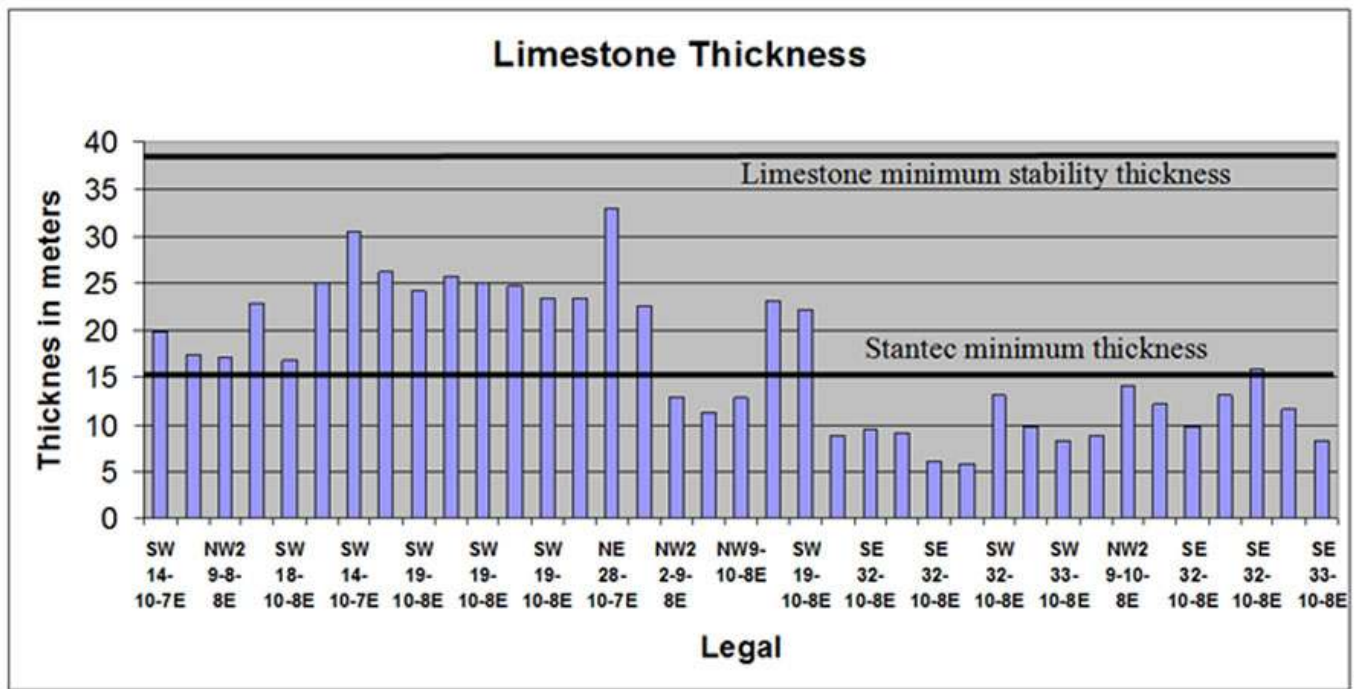
Figure 3. Limestone thickness in the CWS project area taken from drilling reports supplied by Manitoba Groundwater for CWS wells

The full depth of the limestone for well Bru 95-8 at 13.7 meters is less than the Stantec limit of 15 meters. Figure 1 of the questions document illustrates that none of 37 drill reports give limestone thickness in the Bru area over 37.8 meters. In the eastern area where extraction would begin, most limestone thicknesses are less than the unverified Stantec limit of 15 meters. The figure of limestone thickness from the questions document is repeated here as figure 3.

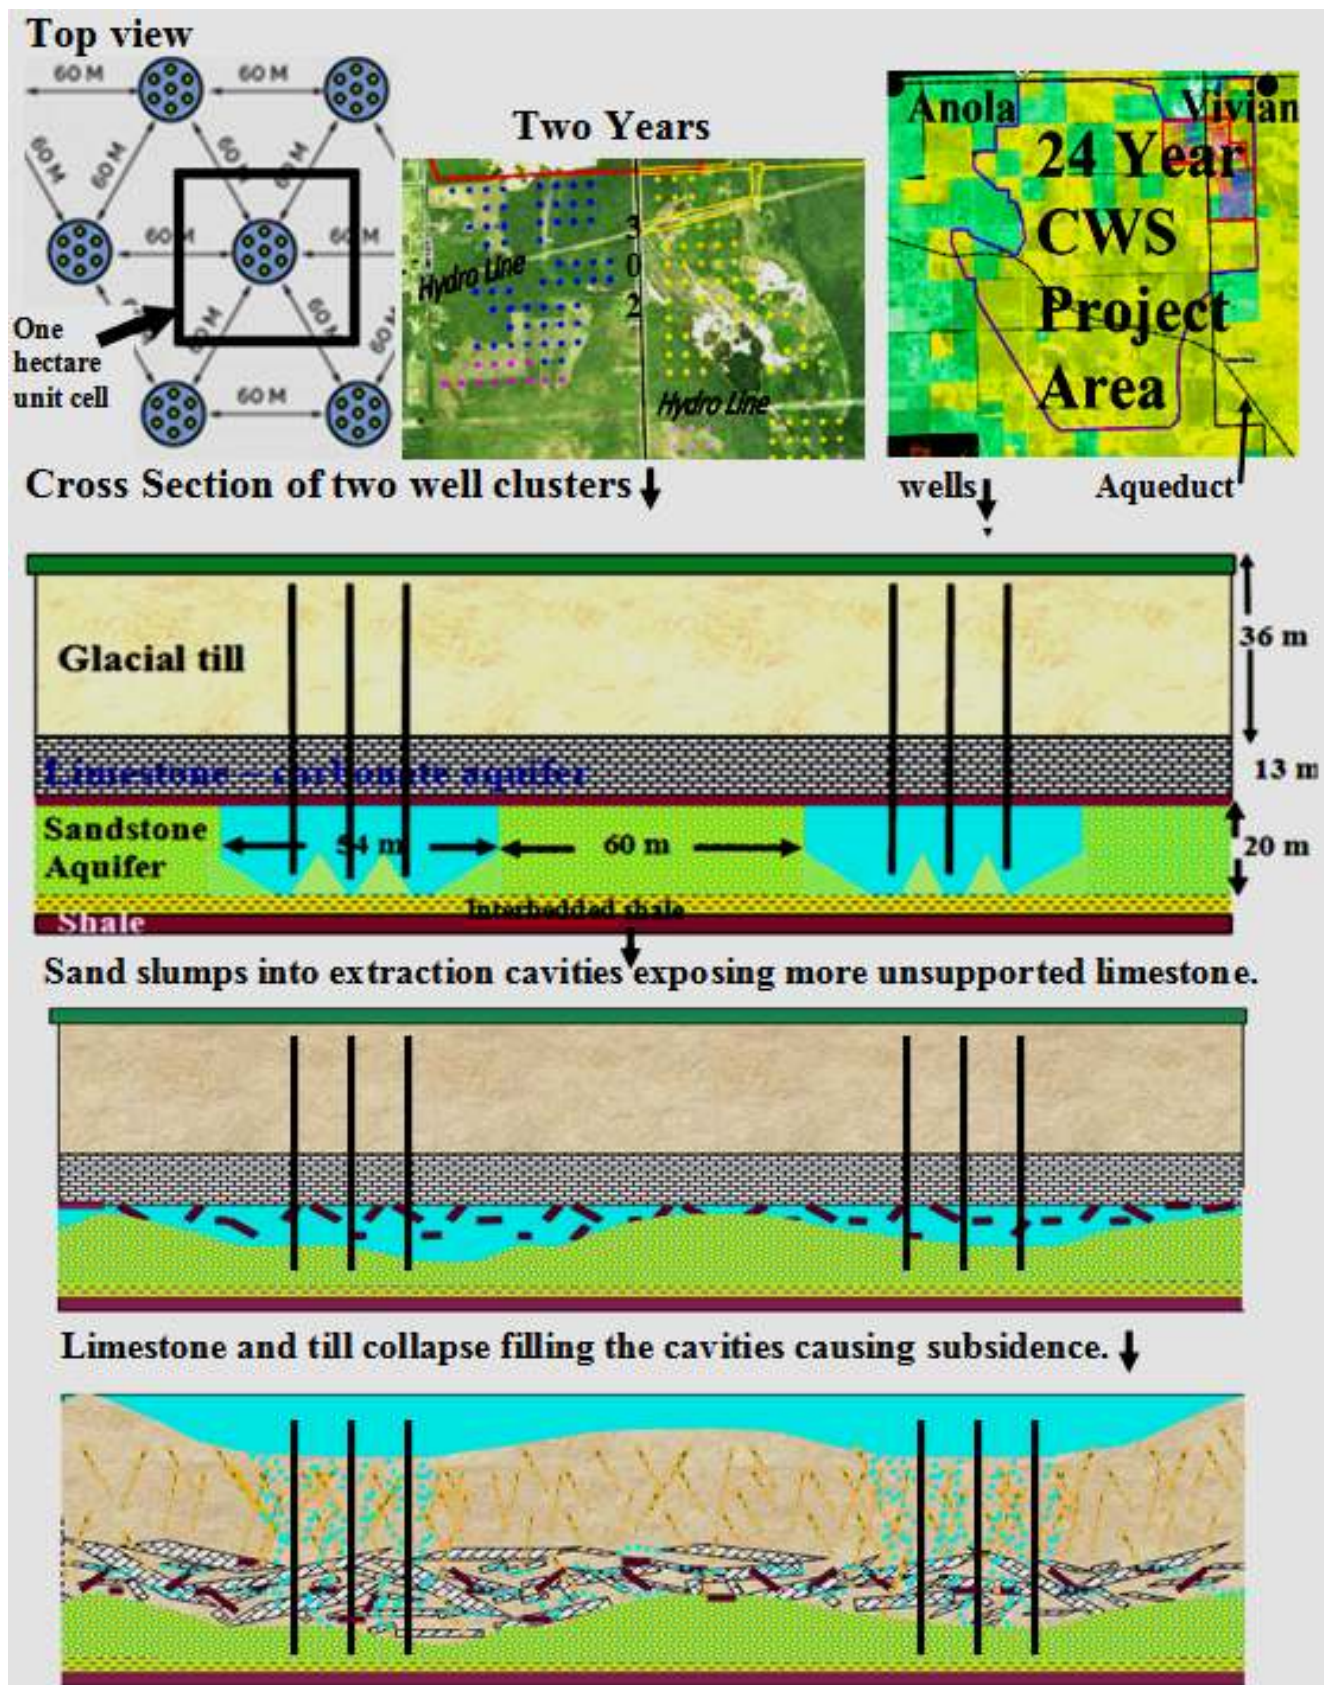
Figure 4. Land Subsidence from CWS well clusters and subsequent aquifer damage and contamination from surface runoff and drainage.

Figure 4 illustrates the progressive slumping of sand pillars into the excavation cavities and the subsequent collapse of the limestone layer. The subsidence and collapse would open the remaining carbonate aquifer to contamination from surface water runoff.

Sand slumping would enlarge the cavities under the well clusters creating an ever more unstable situation. Figure 4 illustrates the geometry of the well clusters and a unit cell within the clusters.

Figure 4 illustrates the land disturbance that would affect the international 500kV transmission line and the Pointe du Bois power line due to land subsidence. The unconsolidated sand around the cavities would slump into the cavities gradually enlarging the area of the unsupported shale and limestone above. The limestone is not thick enough to support the cavities that would increase in size as the sand slumps. The land subsidence could cause the formation of swamps or wetlands around and crossing the hydro corridors. The subsidence would cause land depression and instability within and adjacent to the corridors and transmission lines.

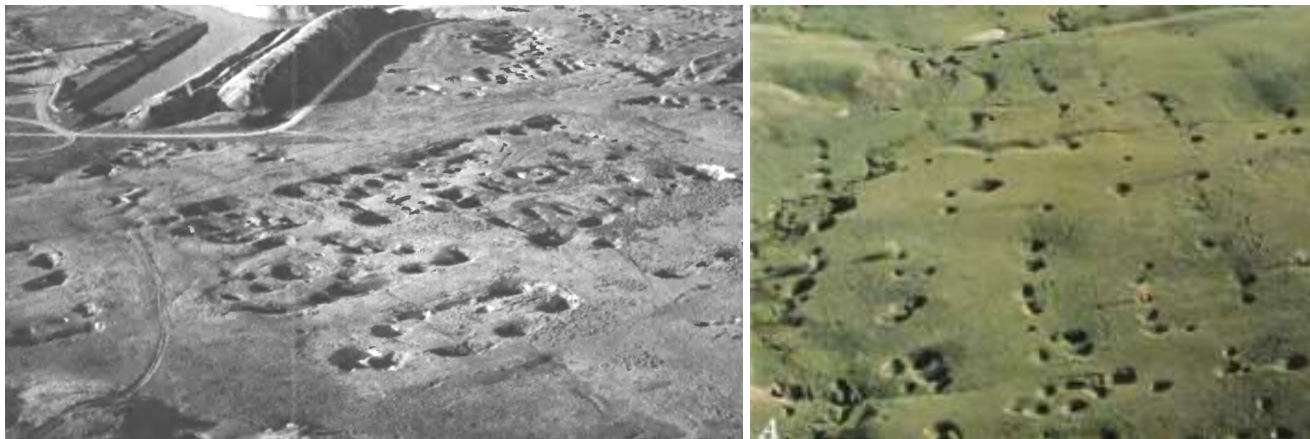
Figure 5. Subsidence and sinkholes at Sheridan, Wyoming from an abandoned underground coal mine²⁷

An example of subsidence has occurred in Sheridan, Wyoming for an underground coal mine abandoned in 1921.²⁷ The mined coal cavities were under a solid supporting coal layer covered by overburden analogous to the CWS sand extraction cavities under solid limestone covered by glacial till at Vivian. At Sheridan the cavities were supported laterally by solid coal pillars. At Vivian the cavities would be surrounded by unconsolidated sand that would not be supporting. Thus subsidence at Vivian would therefore be more likely than has occurred at Sheridan. The general subsidence is punctuated by deeper sinkholes at Sheridan as shown in Figure 5 taken from the Geological survey professional paper describing subsidence at Sheridan in the Powder River Basin.²⁷ Figure 5 foretells the future landscape at Vivian.

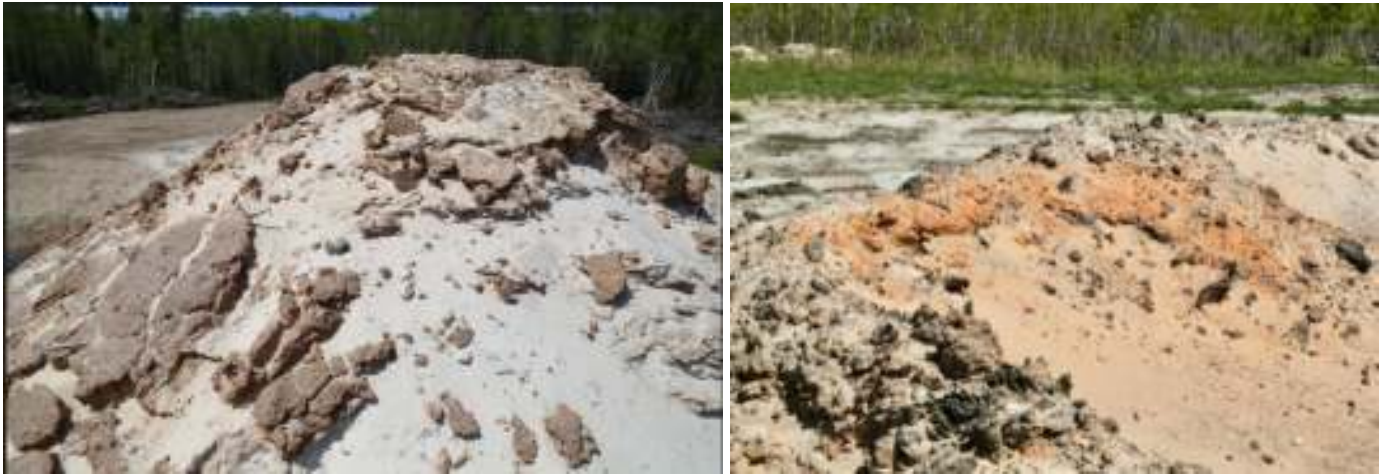
Figure 6. Concretions potentially containing sulphide in pyrite and marcasite in sand piles extracted near Vivian, Manitoba in the spring of 2020.

According to the HDR oversized particles, mainly sand concretions, would be screened out at the extraction site and sent for disposal at a licensed facility. The licensed facility is not named nor is the volume of screened waste material quantified. A paper by Schrieber and Riciputi (2005) identifies concretions formed in the Winnipeg sandstone as containing pyrite and marcasite.⁷ Figure 6, a photograph of extracted sand south of Vivian taken by a nearby concerned citizen in the spring of 2020, shows that the concretions can be large and significant in volume. Note in the second panel of figure 6 the reddish colour indicating oxidation of pyrite.

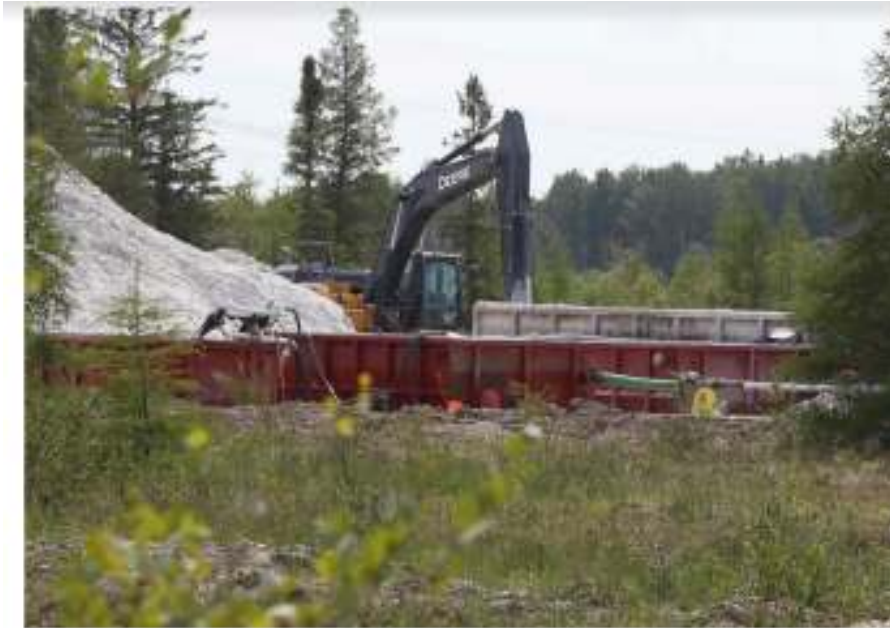
Figure 7. CWS drilling activities in a quarry southwest of Vivian Manitoba commencing in the spring of 2021.

Residents in the town of Vivian have complained about noise levels from CWS sand extraction activities in the LSL quarry pit about two kilometres south west of Vivian that have occurred since the spring of 2021. The noise was from one drill rig and sand extraction from one well, not several operating at once as would occur for the CWS operational well cluster extraction. This is definitive evidence that a 100 meter setback and intervening bush would be ineffective noise attenuation of CWS extraction activities. Figure 7 illustrates the CWS quarry drilling activities.

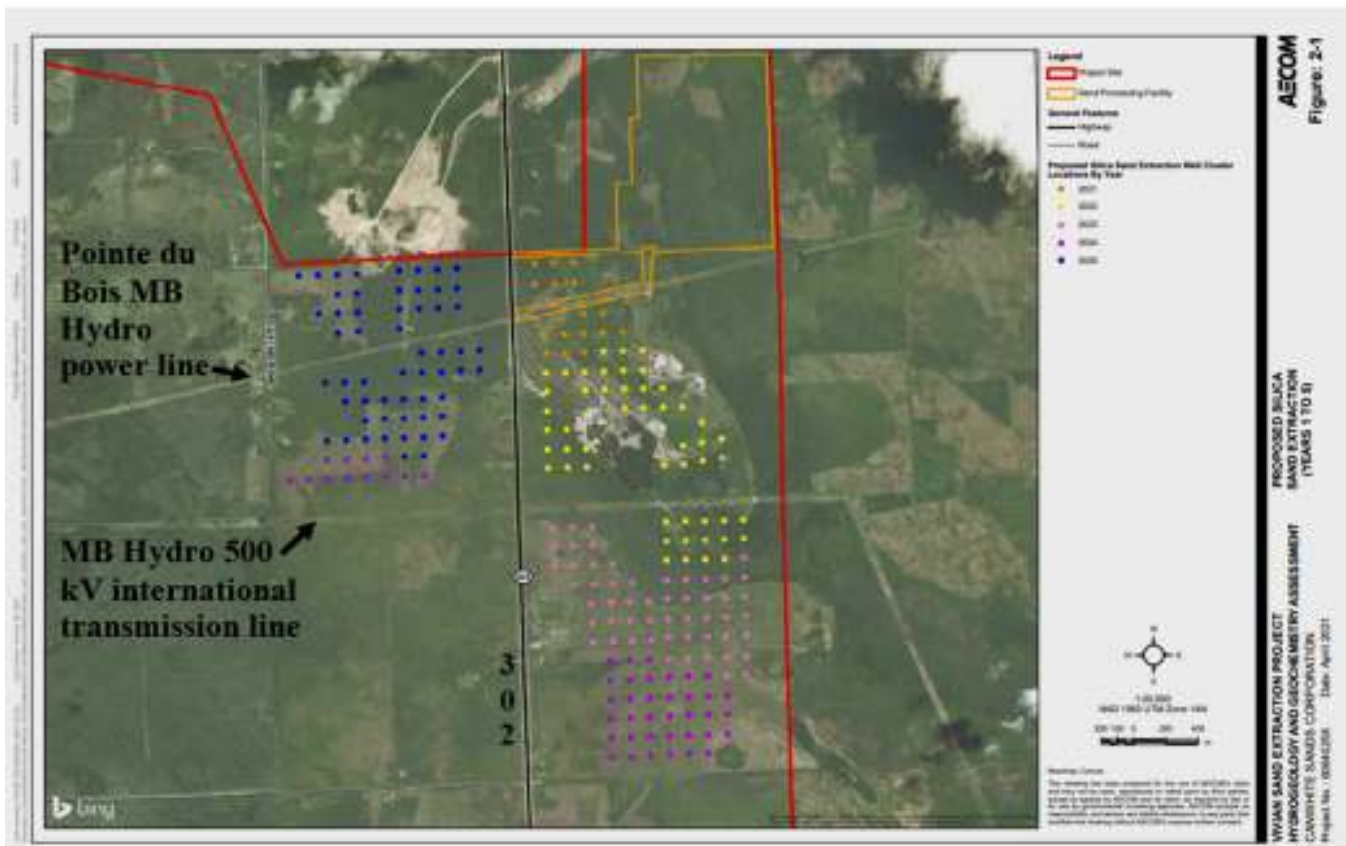
Figure 8. Planned location of CWS well clusters up to 2025 from the CWS HGR

The CWS slurry lines and return recycling water lines would cross two Manitoba Hydro transmission lines one of which is an international 500 kV transmission line falling under the federal jurisdiction of the Canada Energy Regulator Act (S.C. 2019, c. 28, s. 10).³⁶ CWS well clusters would be drilled on either side of the transmission lines as shown in figure 8. The well clusters may cause ground disturbance of the transmission lines. CWS vehicles, equipment and slurry lines would cross the transmission lines.

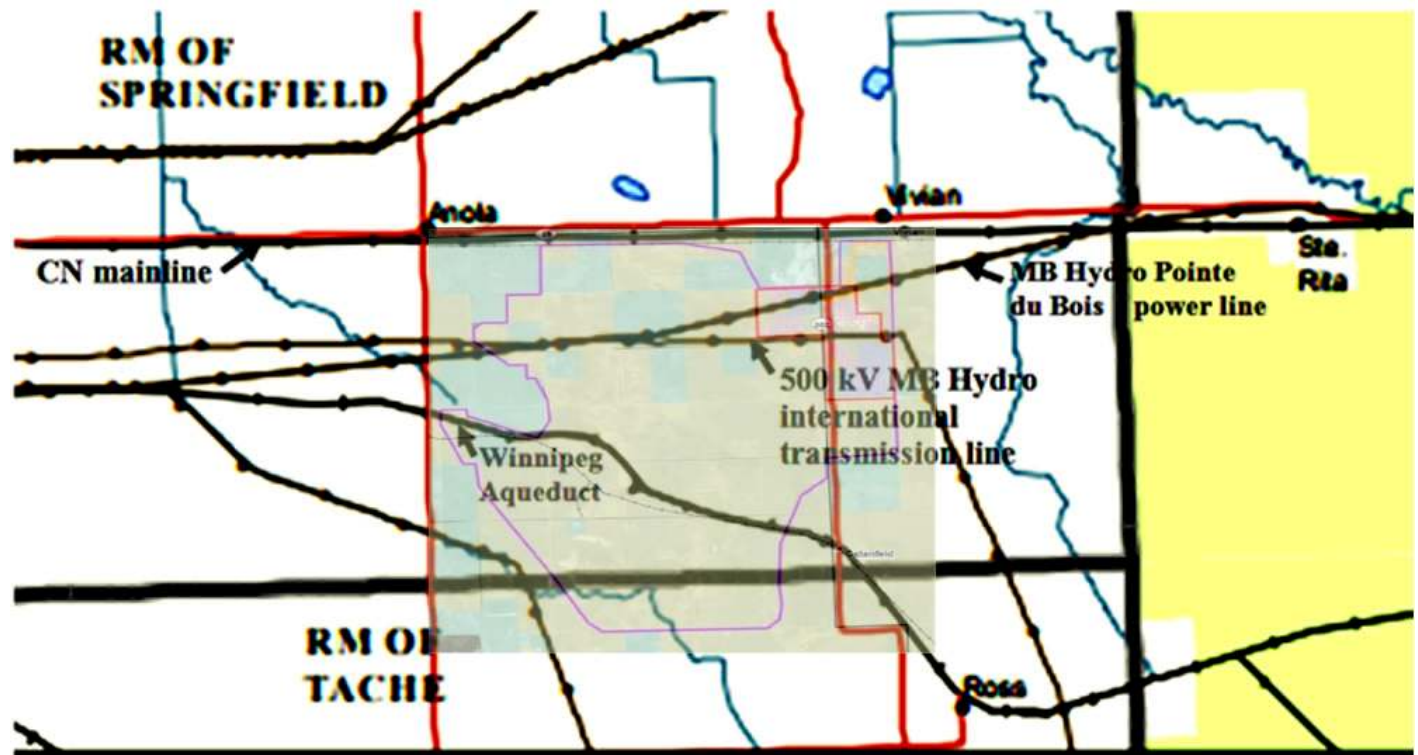
Figure 9. Location of MB Hydro Pointe du Bois power line, the MB Hydro 500 kV international transmission line, Winnipeg aqueduct and CN mainline.³⁷ The CWS project boundary is shown by the purple line

As shown in figure 4 and figure 9 the Winnipeg aqueduct traverses the entire CWS project area. The slurry lines and return recycled water loops would eventually have to cross the aqueduct likely multiple times. The aqueduct is known to have cracks that allow infiltration of surface water.²⁶ Slurry line spills near the aqueduct could contaminate Winnipeg's drinking water supply with harmful microbes, arsenic, selenium, other heavy metals and the highly toxic acrylamide monomer. A major break of the slurry line would leak at a rate of up to 24 cubic meters per minute as documented in the CWS processing plant EAP. The aqueduct could be submerged with a volume of about an Olympic sized swimming pool in two hours. A gradual undetected leak could infiltrate the aqueduct undetected for a long time. The land subsidence and wetlands created by the well clusters on either side of the aqueduct could destabilize the aqueduct and adversely affect drainage around the aqueduct. Flooding of the aqueduct from subsidence wet lands could occur.

The location of the MB Hydro Pointe du Bois power line and the 500 kV International Transmission Line to Minnesota as well as the Winnipeg aqueduct and the CN mainline railway are shown in figure 9.

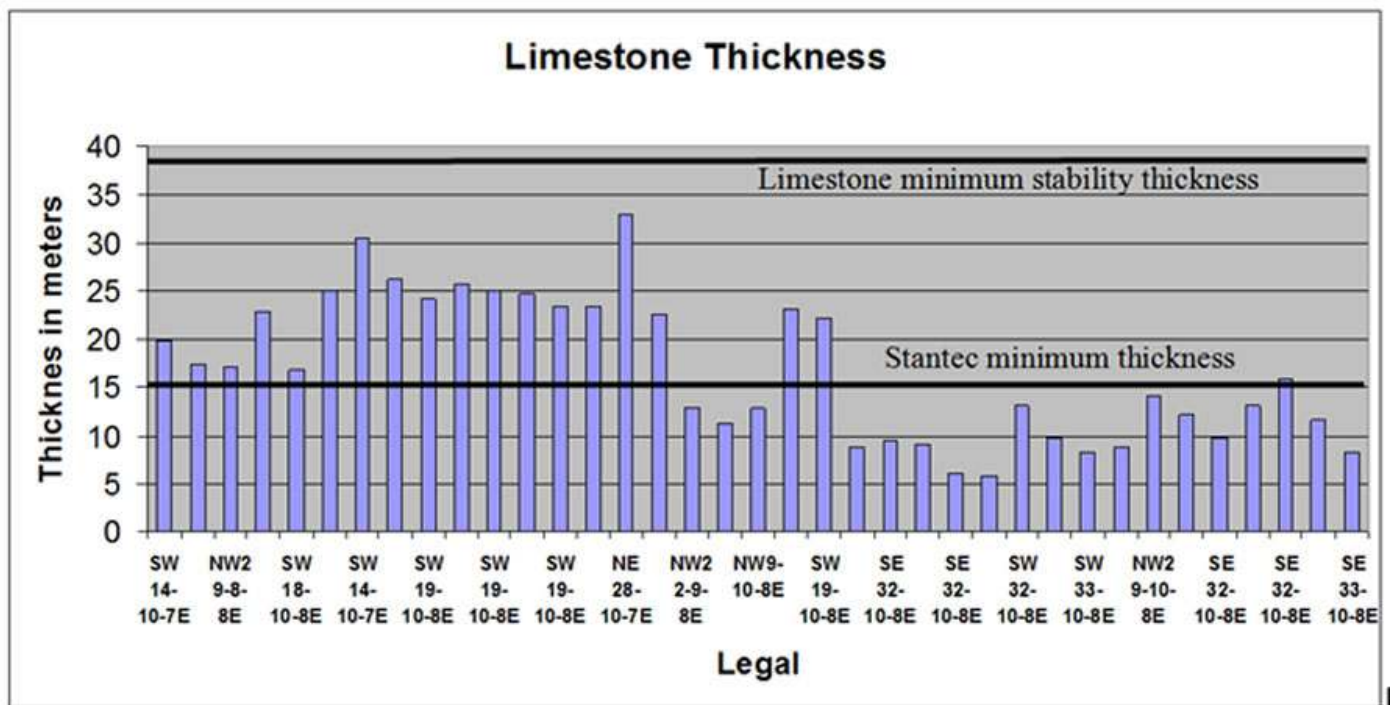
Figure 1. Limestone thickness in the carbonate aquifer of the CWS BRU extraction area.

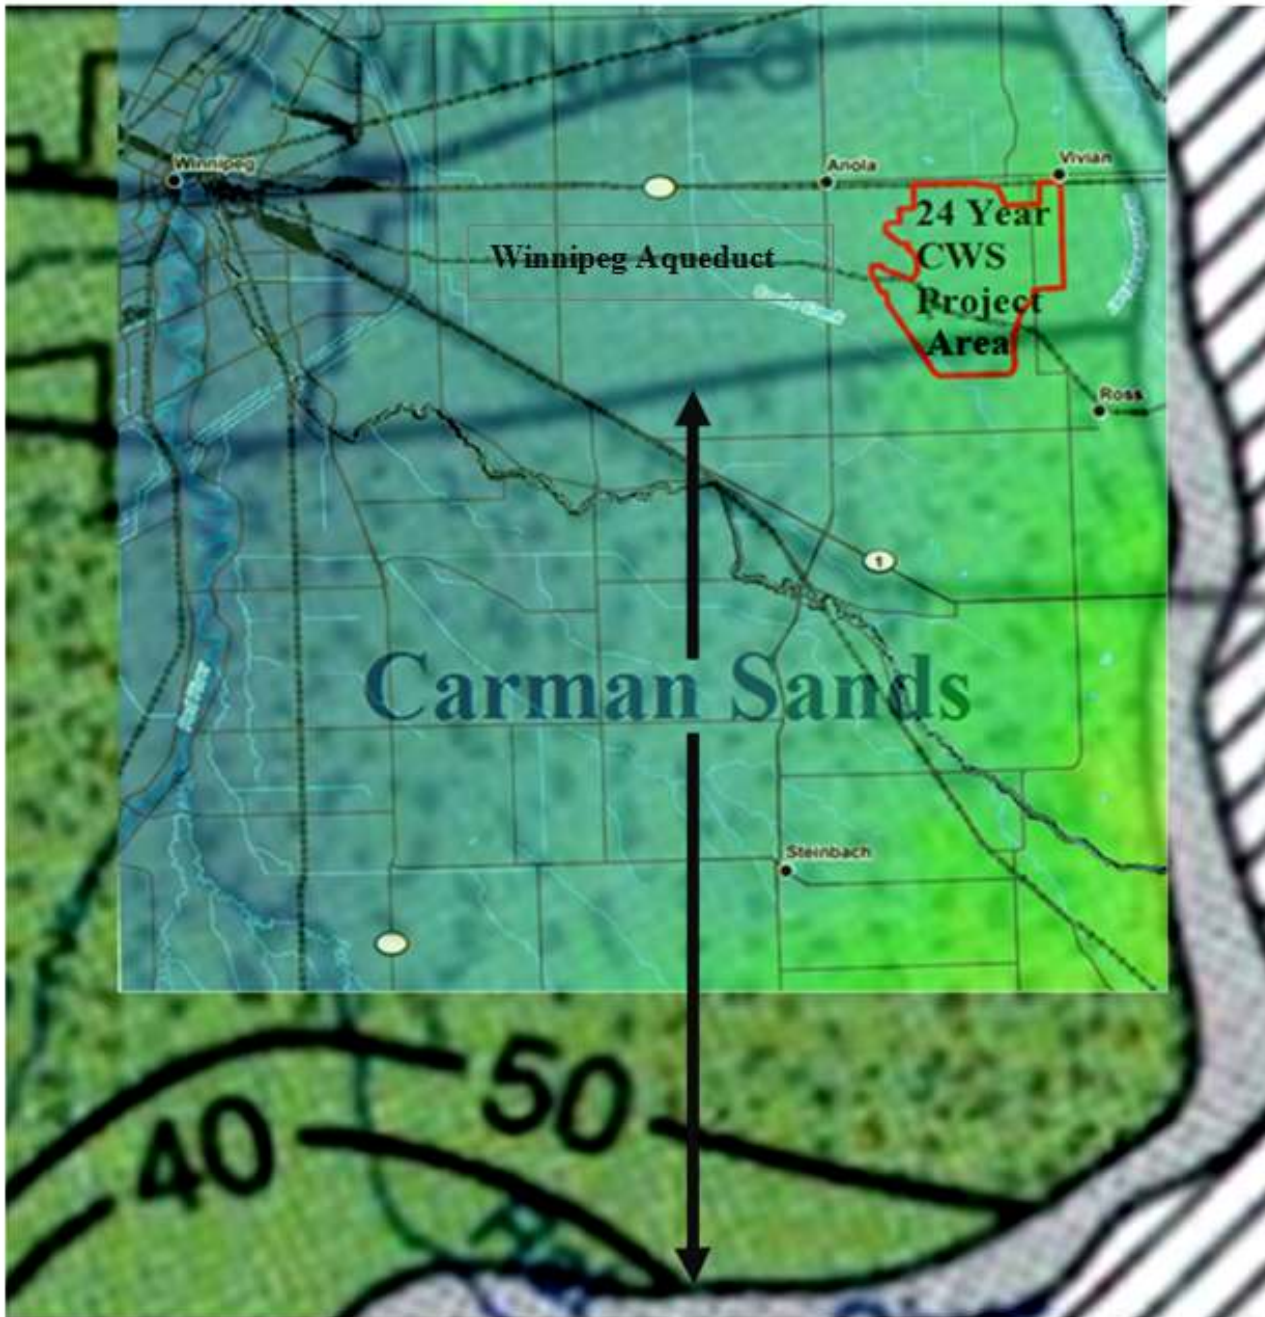
Figure 4. CWS 24 year project area overlaid on the map of the extent of the Carman sands (green speckled area) south of Vivian MB.

Does CWS acknowledge the northern part of the BRU project area is wholly within the Black Island member part of the Winnipeg formation known to contain pyritic shale, marcasite coating the sand, pyritic concretions such as oolite layers and not within the Carman sands area?^{10,12,14,15} Does CWS acknowledge that the Black Island member from which sand will be extracted in the northern portion of the Bru area contains pyrite that will be exposed to re-injected aerated water that will form acid and mobilize heavy metals and selenium thereby contaminating the aquifer?

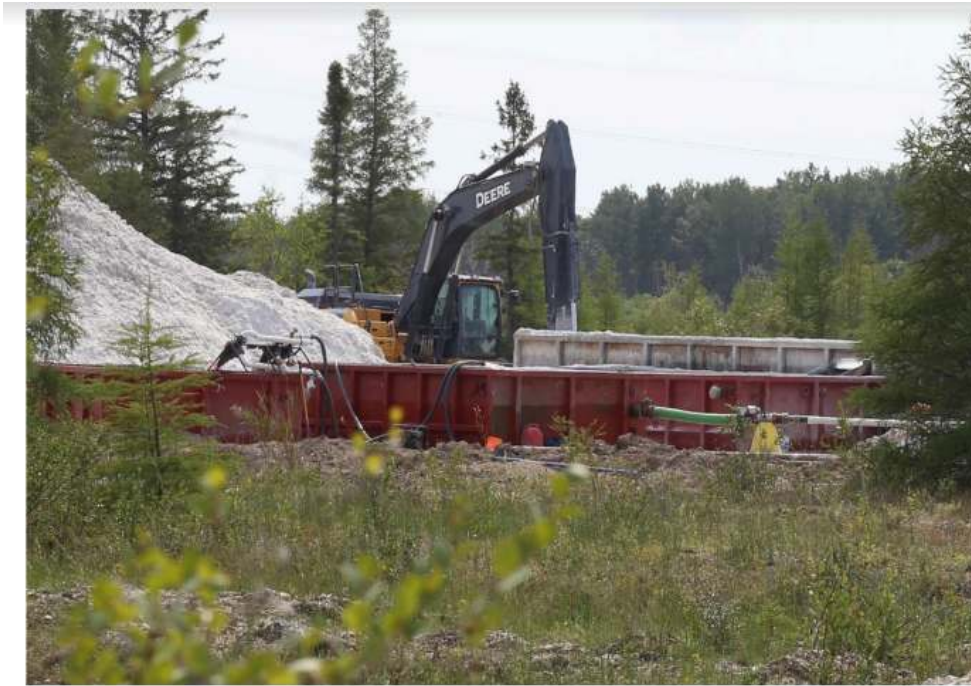
Figure 5. CWS sand extraction activities in a quarry site near Vivian MB Aug. 18, 2021

Will CWS record and report noise levels of such quarry operations and take adequate measures to avoid exposure to silica dust in such operations?
